NATIONAL TRANSPORTATION SAFETY BOARD

B737 Flight Control System
Critical Design Review Report
May 3, 1995

**B737 FLIGHT CONTROL
SYSTEM
CRITICAL DESIGN REVIEW
-REPORT-**

MAY 3, 1995

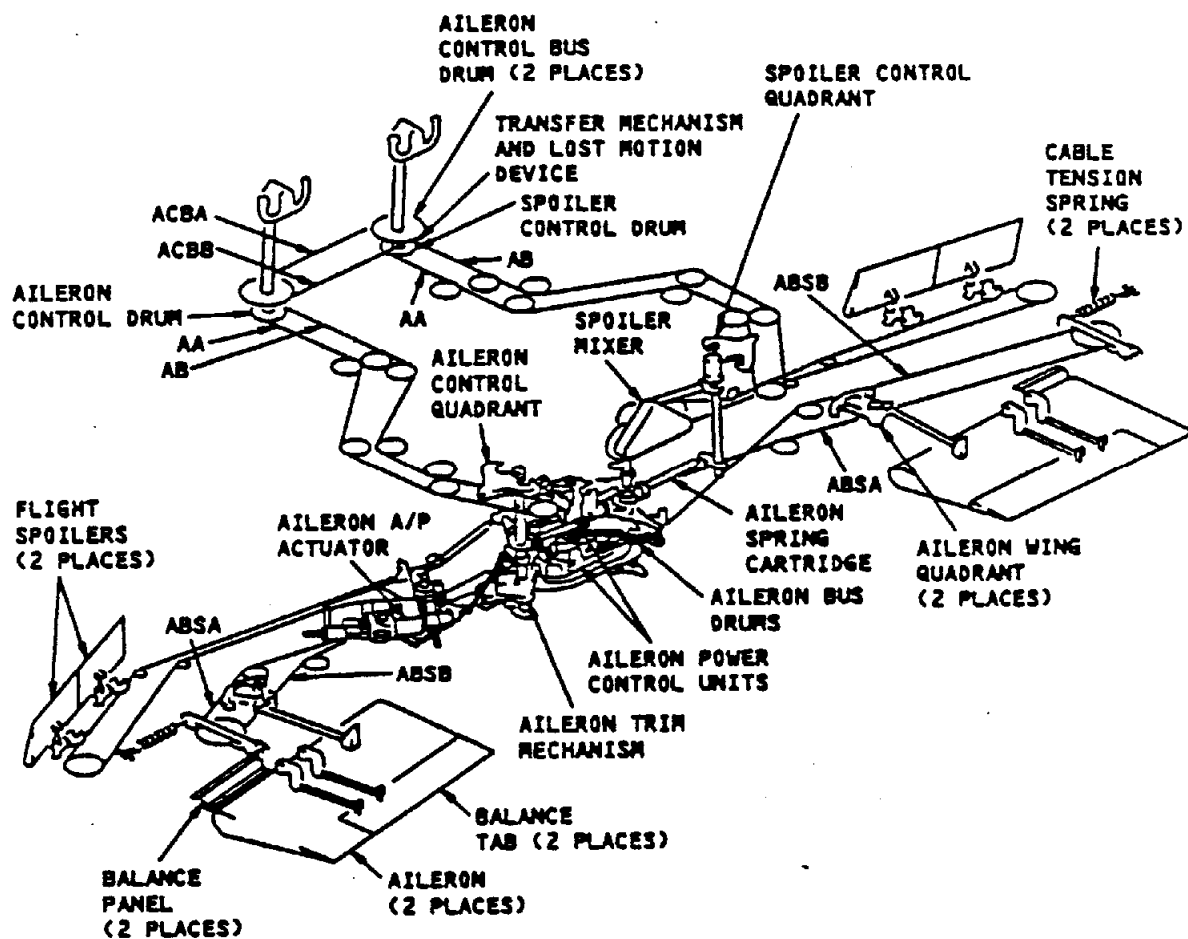
AILERON CONTROL SYSTEM

a. Single Failures, Aileron - The failure mechanisms identified in Table 1 suggest there are a number of ways for a failure to result in a sustained aileron hardover. The significance of the aileron failure conditions resulting in a jam of the aileron is the importance of the alternate means for controlling the airplane. The designed alternative means is the aileron transfer mechanism.

As was experienced in the "M" Cab exercise, flight path control through the aileron transfer mechanism may be very difficult due to the high wheel forces. It is believed that if a full aileron hardover was to be countered for any reasonable length of time, continued safe flight and landing in a B737 would be very difficult. (See "Recommendations For FAA Action," Section 15. Recommendation -8).

Failure conditions associated with the flight spoilers are also identified in Table 1. One or two panel failures (up) in the flight spoiler system did not produce a significant roll control problem as long as the rest of the lateral control system was operative. The significance of this failure is

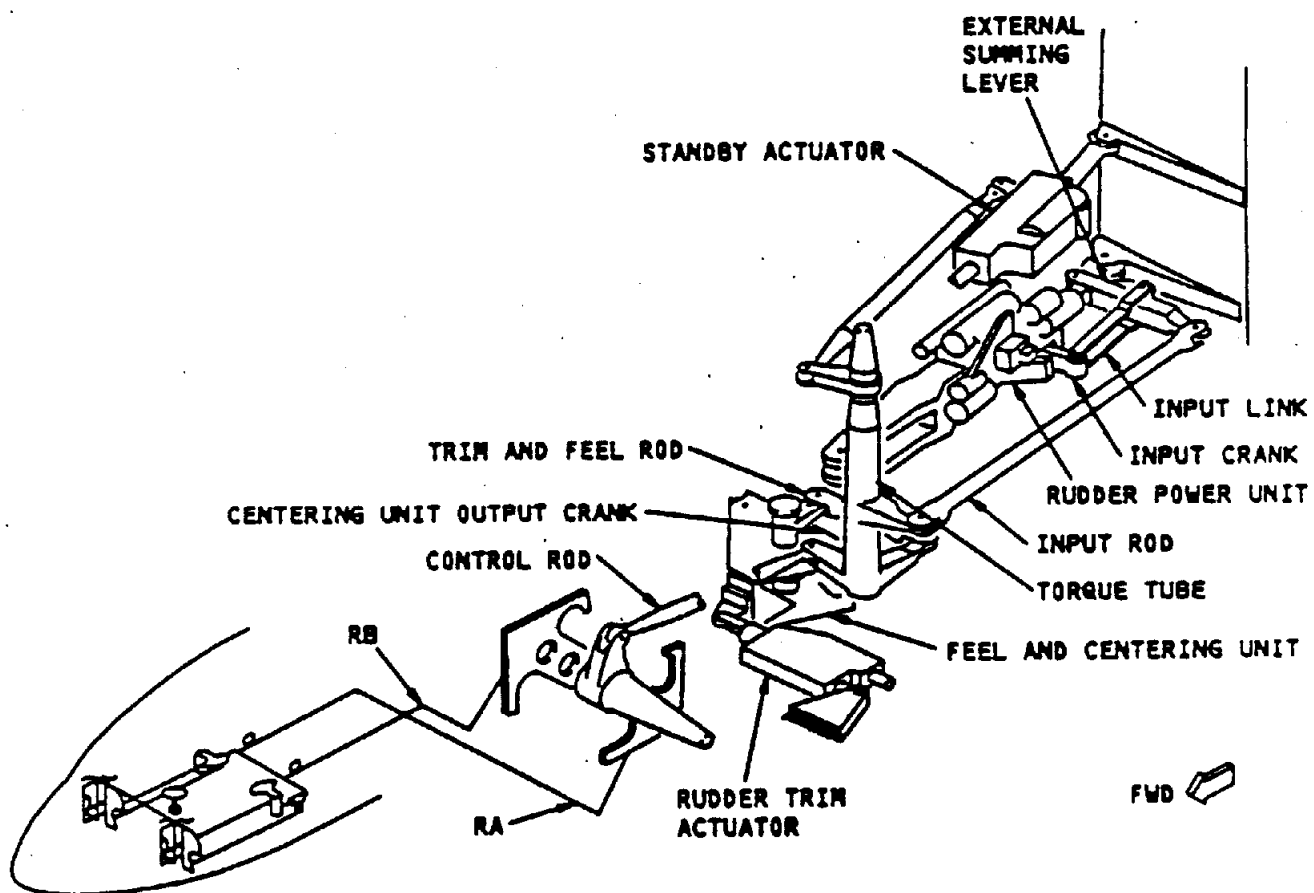
RUDDER CONTROL SYSTEM

b. Single Failures, Rudder - The consequence of the failure mechanisms identified in Table 2 are recognizable by the flightcrew. The failures suggest there are a number of ways where loss of rudder control and potential for a sustained rudder hardover may occur. More importantly, when considering some undetected (latent) failures like Table 4, Items 1 or 2C in the directional control system, in combination with some of the single failures identified in Table 2, the potential for a sustained jam of the rudder at full deflection, as limited by blowdown, is increased. The Team has determined the requirement for full rudder is within the scope of normal operation. Since full rudder hardovers and/or jams are possible, the alternate means for control, the lateral control system, must be fully available and powerful enough to rapidly counter the rudder and prevent entrance into a hazardous flight condition.

The failure condition identified in Table 2, Item 3, has not been fully defined. The yaw damper mod piston and pilot input summing linkage are a vital part of the main rudder power control unit. The interaction of the yaw damper and pilot input through the mod piston and the summing linkage with the dual spool servo valve is complex. It is this linkage that limits the force that the pilot can apply to shear an obstruction in the servo valve. Whether there is a failure mode of this input/summing mechanism that could result in a yaw damper authority of greater than 30° or could result in a servo valve open condition that produces a rudder hardover was not clearly established to the satisfaction of the team. (See "Recommendations for FAA Action" Section 15. Recommendation -12, -13).

Failures identified in Items 8 and 9 of Table 2 can be confusing to the flightcrew and could result in inappropriate flightcrew response. This is because the crew's primary indicator of rudder position is rudder pedal position, and these two failures cause displaced pedals and inoperative pedals. Flightcrew training in the recognition and proper response to these failures is recommended to assure continued safe flight and landing. (See "Recommendations For FAA Action," Section 15. Recommendation -19).

The rotary valve input on the rudder standby actuator (Table 2, Item 6) produced by Dowty is fitted with a journal bearing arrangement. The rotary input crank material is heat treated to 440°C and a hardness R_c 55-59. This crank rotates in a stainless steel housing heat treated to R_c 35-37. This combination of materials and limited clearance, operating without lubrication, or with only Skydrol lubrication after a recent modification, continues to result in minor galling of the two members, therefore the potential for jamming of the input to the rudder has not been totally eliminated. (See "Recommendations For FAA Action," Section 15. Recommendation - 15).
